Analysis of passive fire protection measures in real fires –
Slovenian National Building and Civil Engineering Institute
- a short overview of a research work (sponsored by a
governmental grant)

Ales Jug

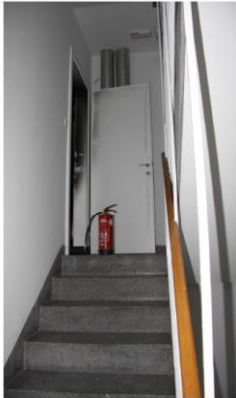
Fire rated door – non exposed side

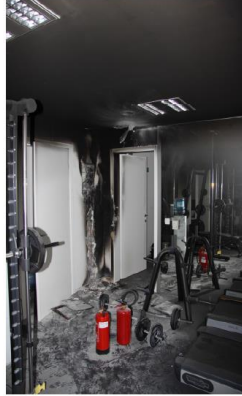
Fire rated door – exposed side

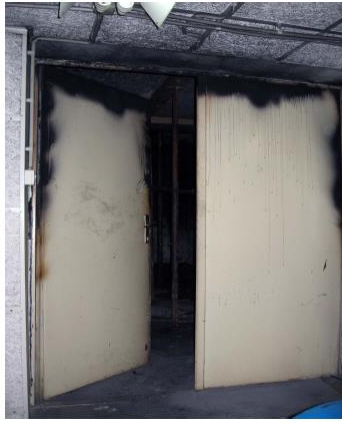
Fire rated door – non exposed side

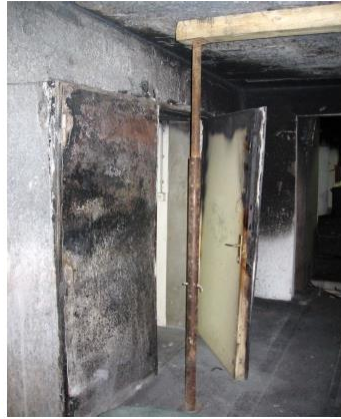
Fire rated door – exposed side

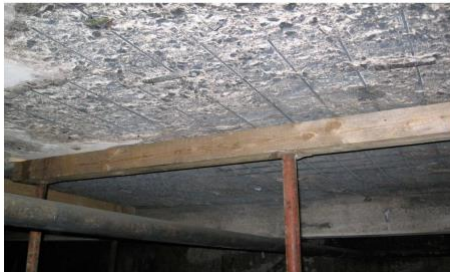
REI 60 ceiling

Significant constructional damage

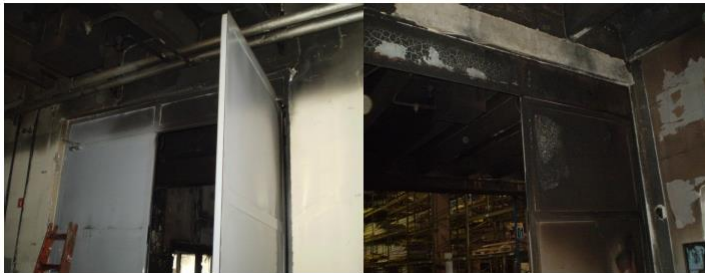
Fire rated door – non exposed side

Fire rated door – exposed side

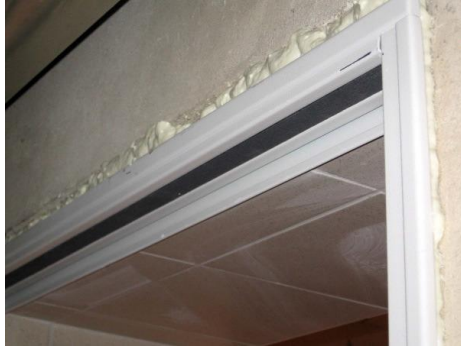
combustible gap filler on a fire rated glass

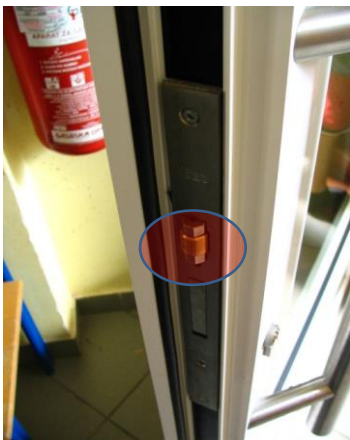
Inadequate lock on a fire rated door

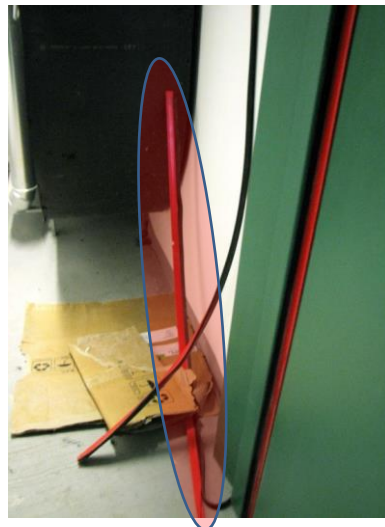
improperly attached fire rated seal
